SEATTLE JAPANESE GARDEN

POND RENOVATION PROJECT

February 25, 2014 Completion Inspection

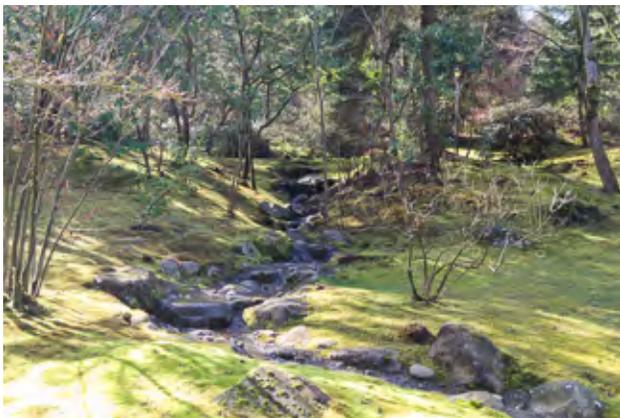
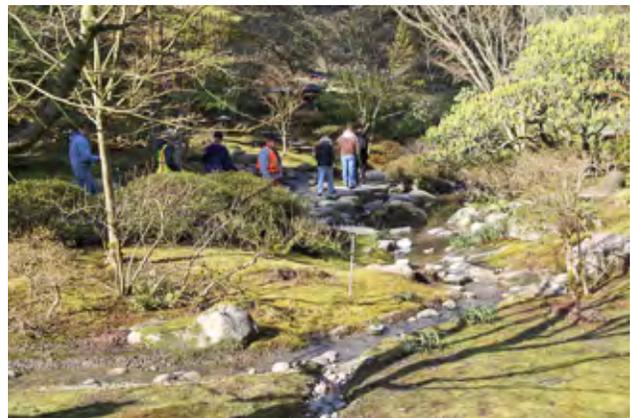
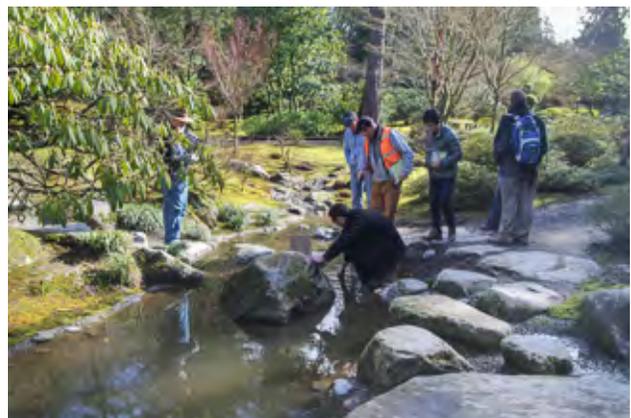
The upper stream beds having been lined in previous years, the primary task of this part of the project was to remove accumulated sediment from the headwaters just south of the pond, then line that area of the stream with concrete.

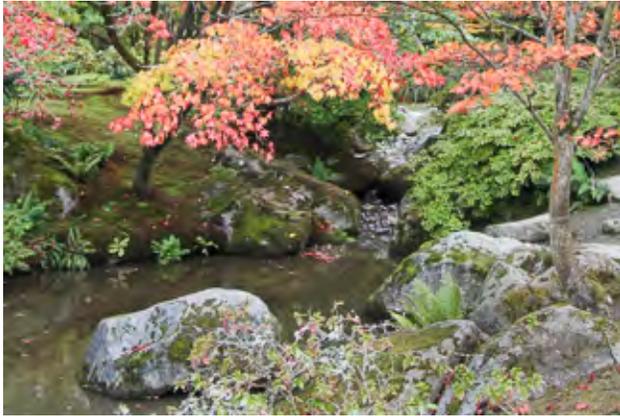
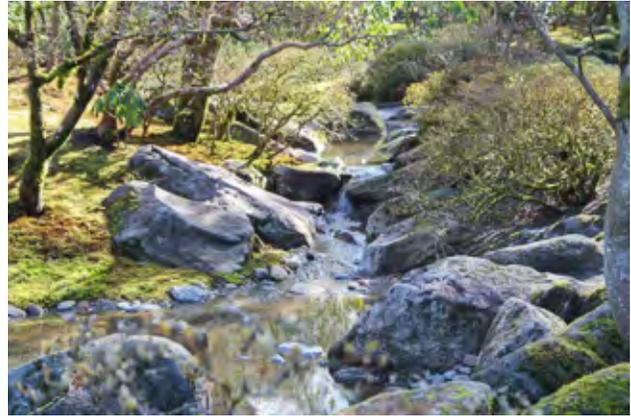
October 2012 - Before

February 2014 - After

Above left shows the stream at the headwaters of the pond in the fall of 2012. Above right the same area after this project renovation. A small waterfall has been restored at the south end of the headwaters which now again contributes to the garden's ambience with its quiet gurgling sound.

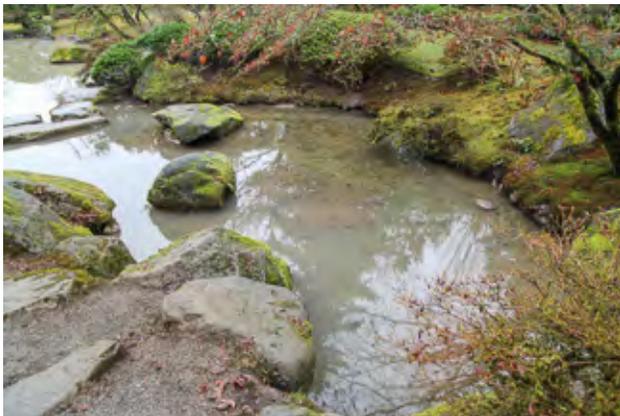
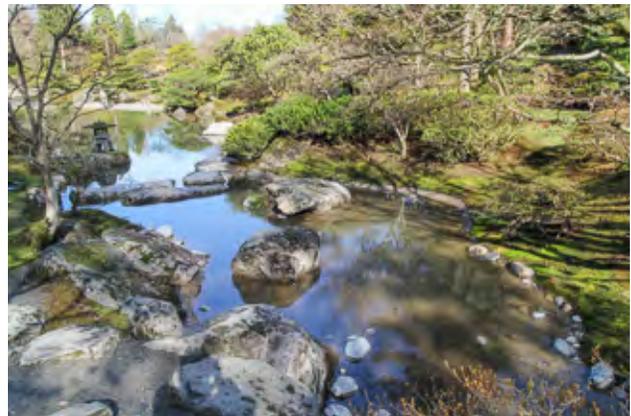
February 2012 - Before

February 2014 - After

Above left shows the deteriorating banks and the catch basin area filled with sediment made worse after a water pipe broke on 26th Avenue above the garden in February 2012, washing much dirt and mud down the hillside and into the garden. Above right is the catch basin on February 25, 2014, after this winter's project's completion.

This winter, Turnstone hand dredged the muck from the headwaters area of the pond, working through a number of inches of brown clay down to the native gray clay. While the original plan was to excavate deeper, it became clear that doing so would undermine the soil under the stepping stones. The catch basin is now about 12" deep, with a concrete lined bottom. The purpose of the catch basin is to collect sediment from the streams and the south end of the garden before it enters the pond and to make periodic sediment removal easier. Turnstone lined the pond bottom with high strength, steel reinforced structural concrete coated with a natural colored, stream textured mortar. At the same time, Turnstone repaired and stabilized the banks in the headwaters area.

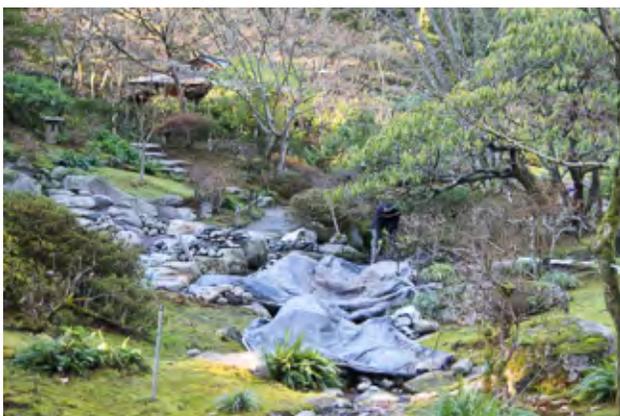
Stream Work in Progress - December 2013

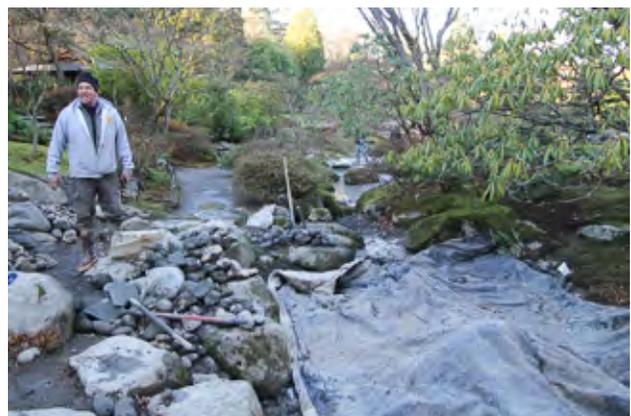
Paul Keller At Work - December 2013

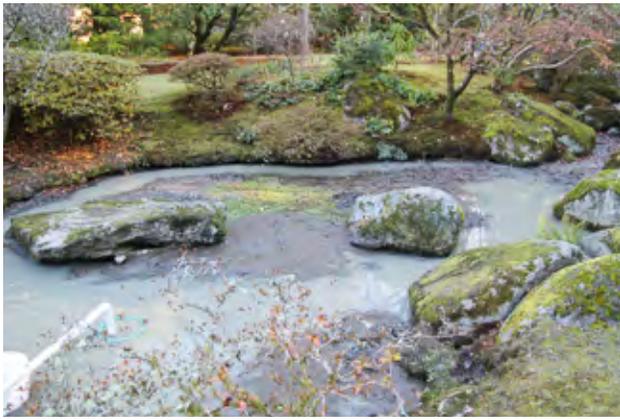
Pond Work in Progress - December 2013

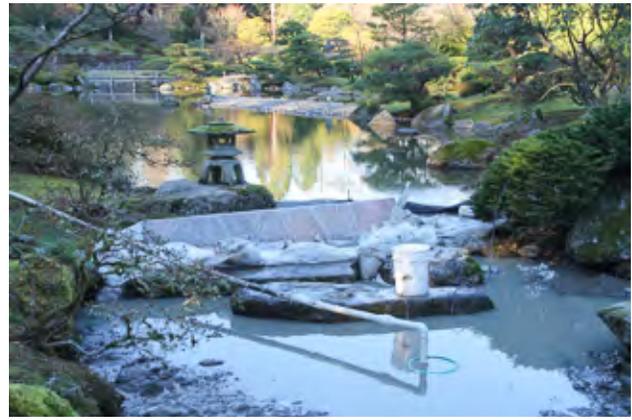
Pond Cofferdam & Work in Progress - December 2013

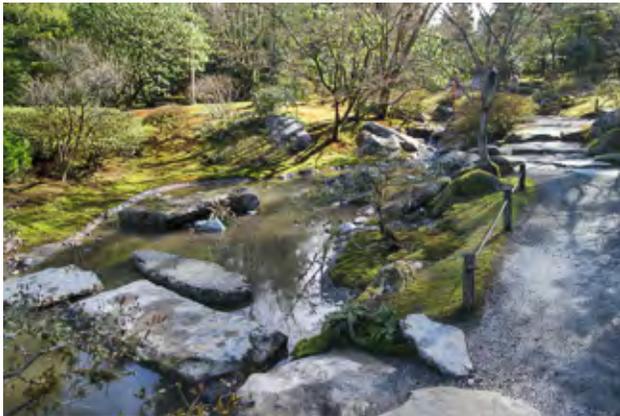
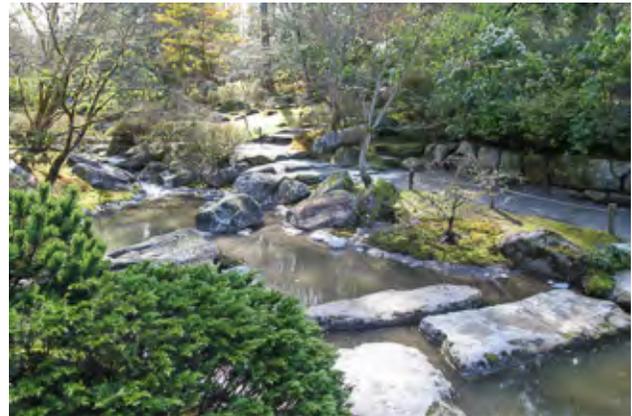
February 2014 - After Completion

A small culvert from the roji also drains into this headwaters area. That water is filtered through a French drain system around the tea house. This winter's renovation of the catch basin area has temporarily revealed the outflow of this tea house drainage system, but that will soon disappear again as moss and vegetation grow back to cover the banks of the headwaters.

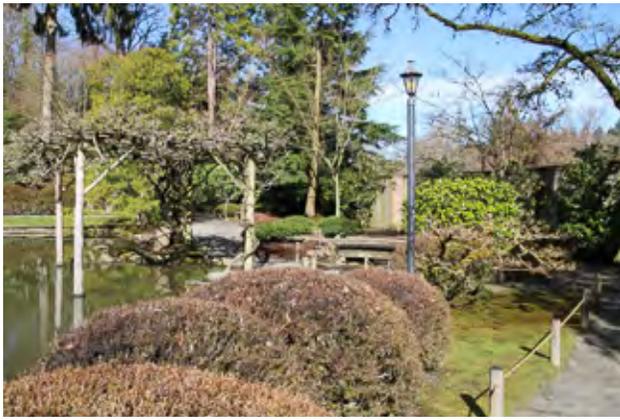
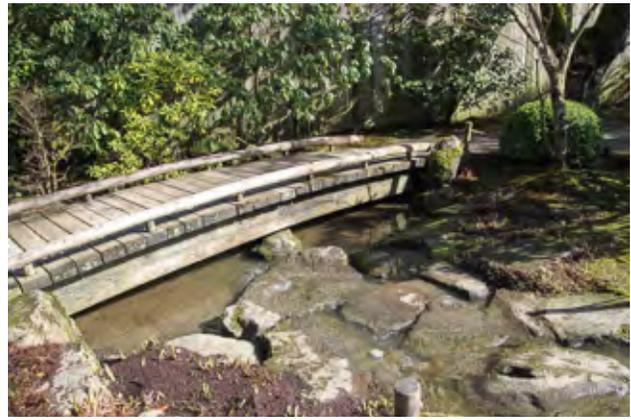
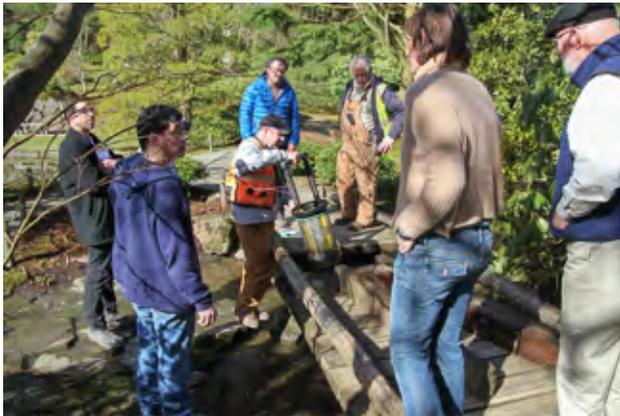
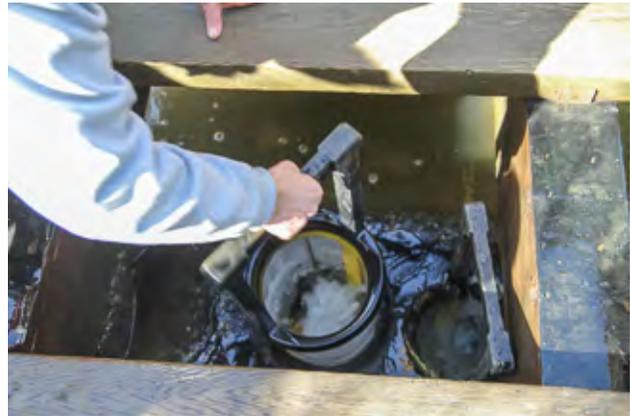
The pond outflow passes under the wooden bridge between the wisteria trellis and the east fence, then flows through a weir where debris is filtered by baskets which gardeners access for cleaning by removing three wooden bridge planks.

Turnstone replaced the old outflow filters with 2 larger filter baskets of finer mesh. The new baskets' larger size increases the filter area and improves water flow into the recirculation vault outside the fence. Gardeners will clean these 2 new filter baskets once each day. The process takes about 10 minutes to remove the bridge planks, pull up and clean the baskets, then put everything back in place.

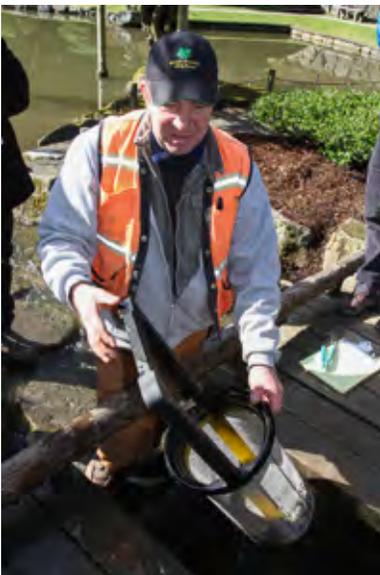
Paul Keller & Filter Basket

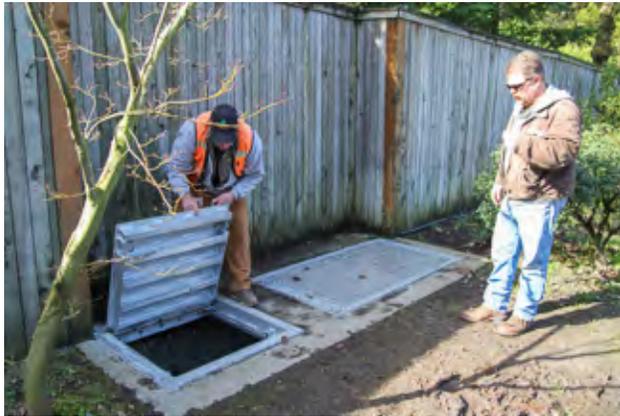
Recirculating pond water is filtered again in the 12 foot deep overflow vault located outside the fence along Lake Washington Boulevard before going to the pumps. Excess water such as after storms spills from this vault through a culvert under Lake Washington Boulevard to Arboretum Creek.

New Vault Covers - 2014

Turnstone replaced the old vault covers with lighter weight lids and the old stainless steel filter screen from the 2003 renovation with a heavy duty, long lived, more easily cleanable, plastic, 5/16th mesh screen. These improvements make cleaning this filter much safer and easier.

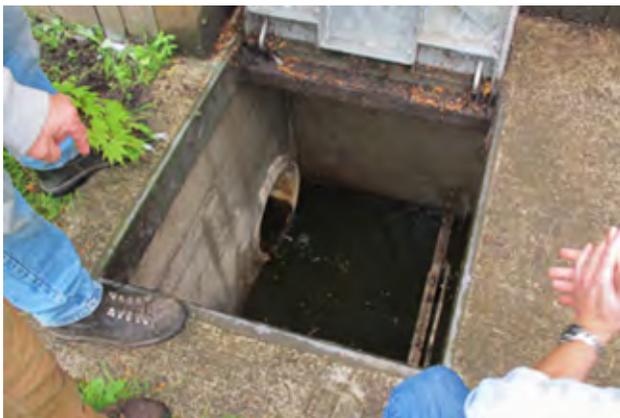
Old Mesh Filter from 2003

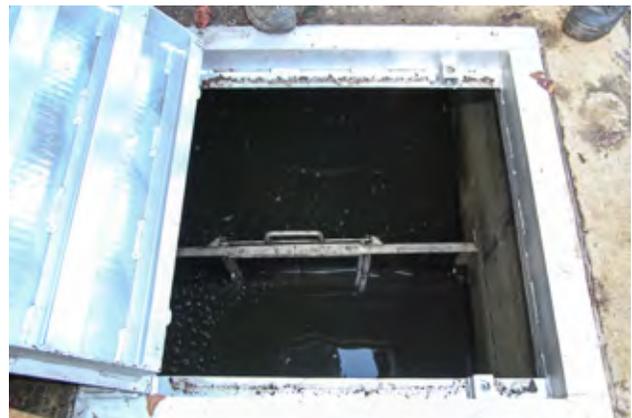
New Plastic Mesh Filter 2014

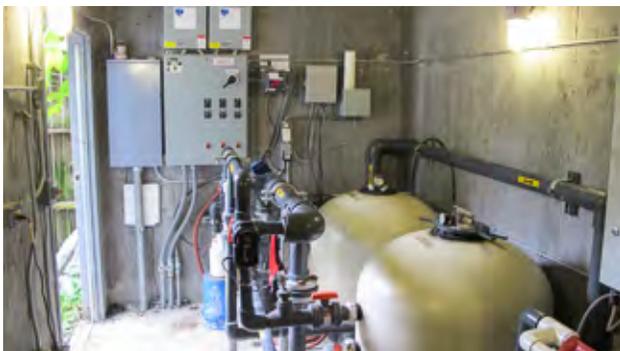
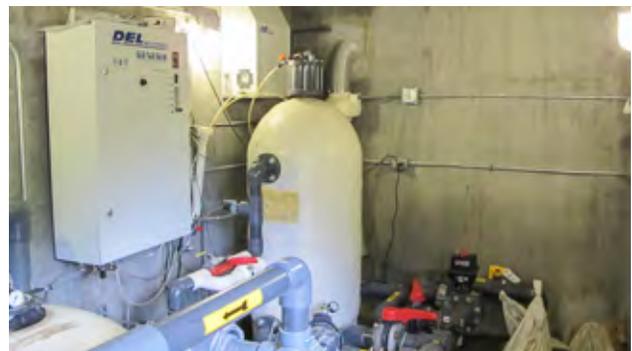
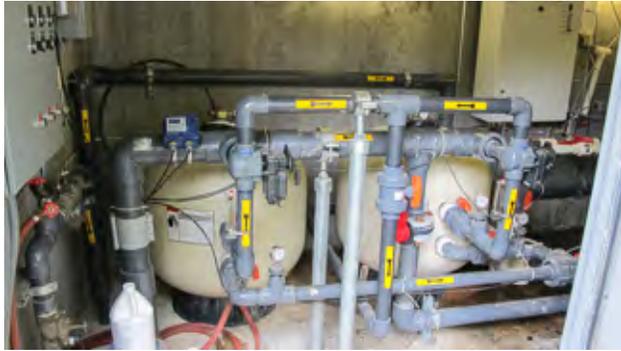
The pumps and controls from the 2003 renovation filled the mechanical room and were more suited to circulating water in swimming pools than in chlorinated ponds. Turnstone replaced the 2 aging and inadequate recirculating pumps plus pipes, valves and controls with a more suitable and efficient system.

Original pumps and Controls from 2003

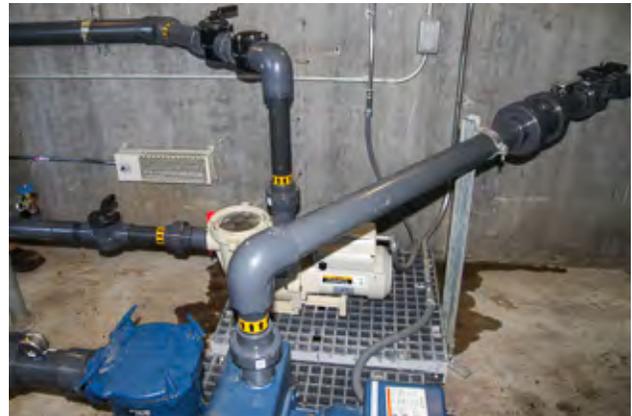
2 New Smaller Improved Pumps - 2014

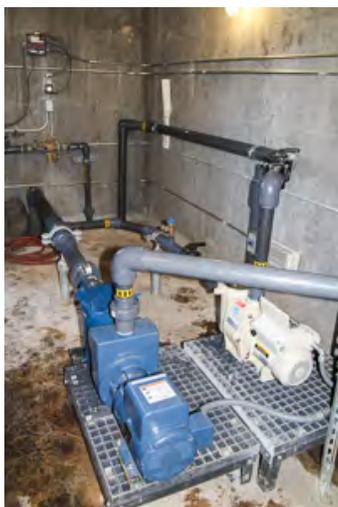
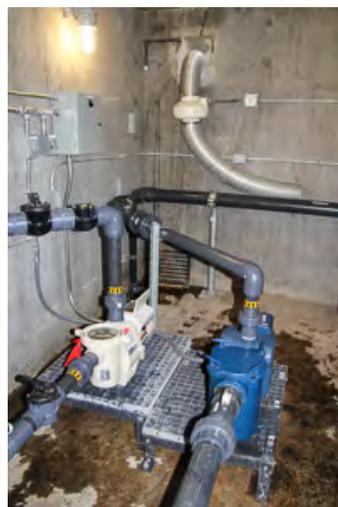
2 New Intelliflo Pumps - 2014

The new blue pump feeds the waterfall and stream. The smaller new white pump recycles water directly back into the pond for aeration. Each pump has one last filter that can be

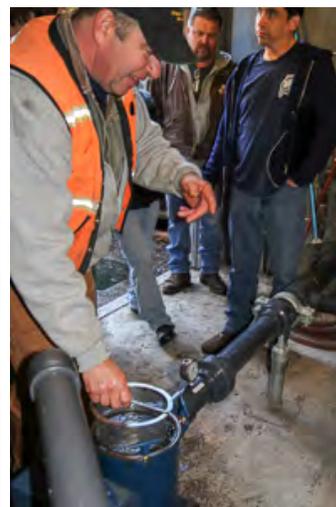
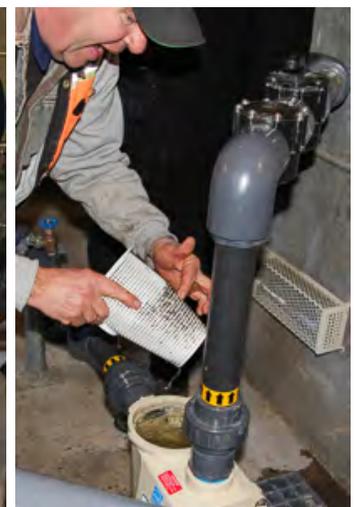
Additional Cleanable Filters on each Pump - 2014

easily cleaned. Thus pond water is filtered 3 times before entering the pumps. This filtering system helps to reduce clogging of the pumps, but all filters need to be cleaned on a regular schedule to be most efficient.

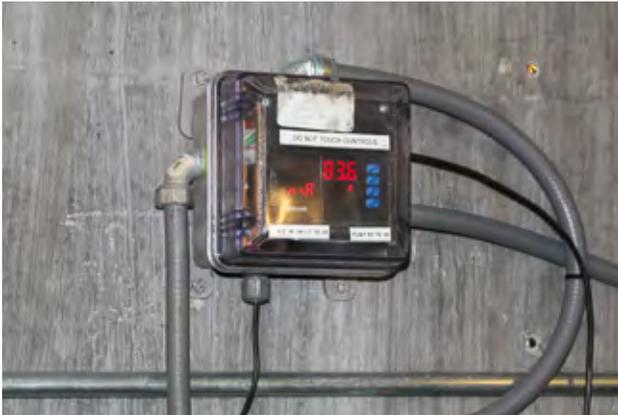
Master Water Intake Control - 2014

Each pump has its own individual control. An additional master control shown above left monitors the water level in the outflow vault. In the photo the water is 83.6" deep. If the level drops to 55" the control will add city water to the mix. If the level drops below 40", the control will automatically shut off both pumps. Turnstone also installed a small room heater to prevent the pumps from freezing in winter.

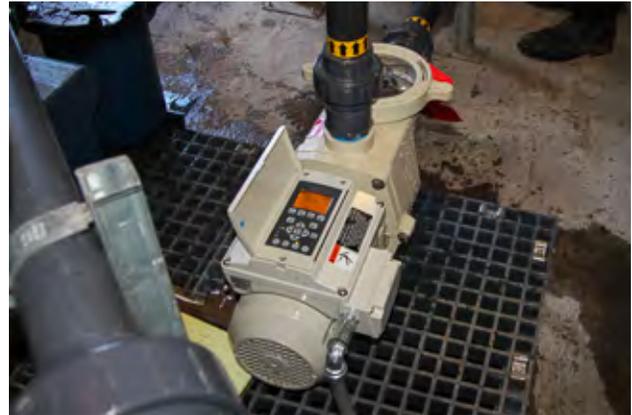
White Pump Intake Control - 2014

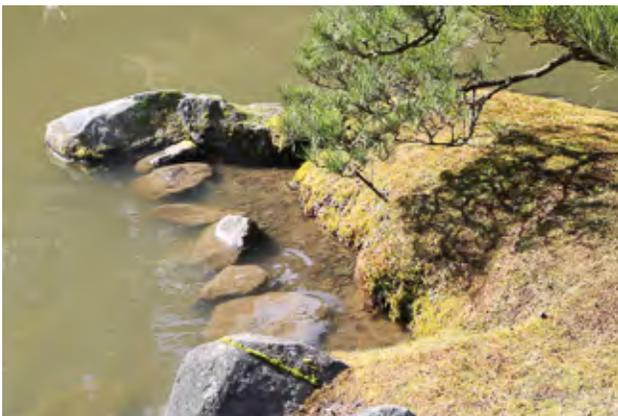
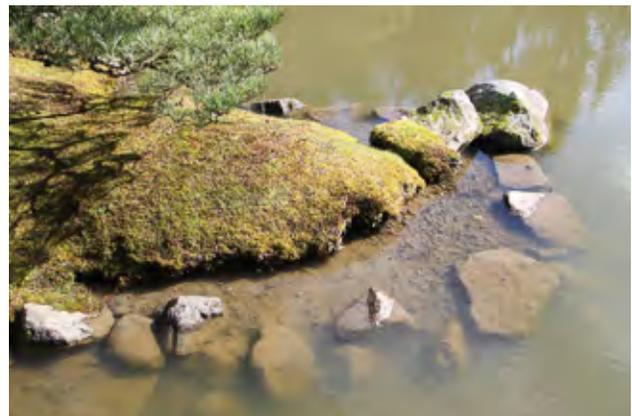
As the inspection group left the garden, they surveyed the most critical needs for future projects: the eroding banks of the pond's islands between the bridges.

Eroding Island Banks - 2014
